# Part 4 - Repairing Broken Condensers

By: Bill Mohat / AOMCI Western Reserve Chapter

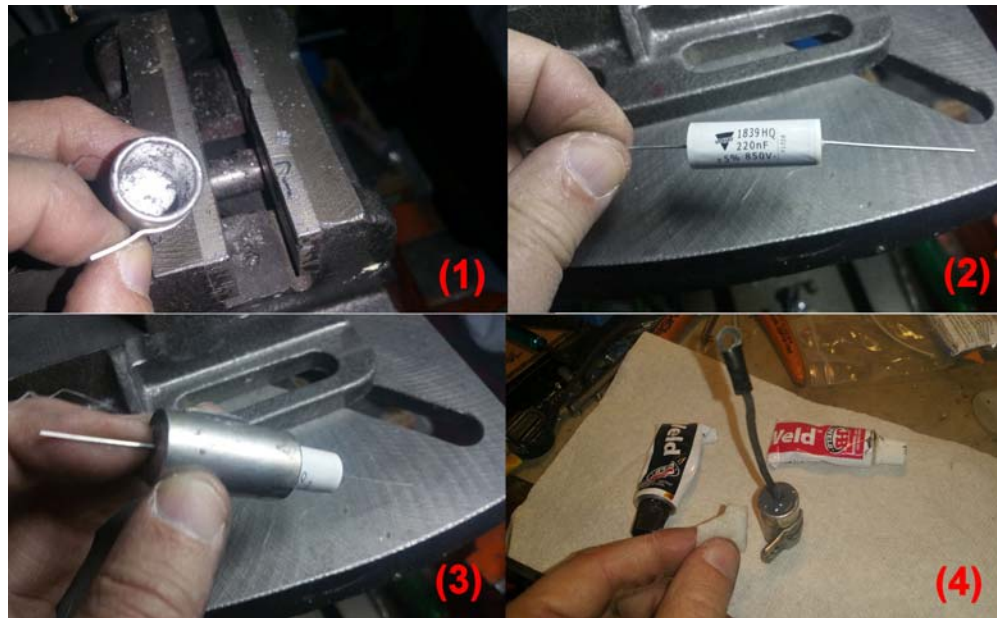
**Fig. 1 - Rebuilding Film Condensers**

- (1) Drill out the body of the old condenser. Remove ALL pieces from the old metal can.**
- (2) Select an appropriate replacement mylar cap.**
- (3) Drill hole in bottom of can, and insert new cap.**
- (4) Solder wires onto new capacitor, and re-seal the metal can with a good epoxy.**

Here's the process I use to rebuild the larger old condensers. (See Fig. 1, below):

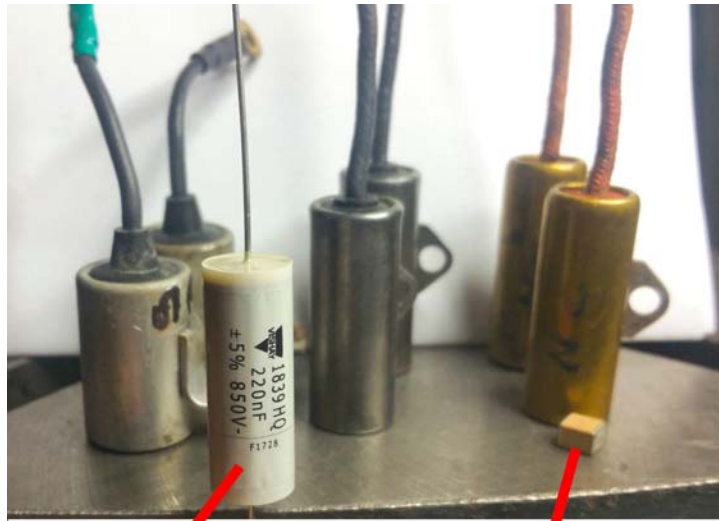
**Fig. 4 - Size Comparison**

**Standard Poly Film Capacitor is too tall and wide to fit in many smaller condenser cans.**

**X7R Ceramic Capacitors are TINY, and should fit in almost any application.**

These ceramic elements are TINY, compared to their Mylar Film counterparts. Take a look at how small they are, compared to the Vishay Mylar Film capacitors. Note how the Mylar Film condenser core probably can NOT fit many of the short, or narrow, condenser cases....which should be easy for the X7R “chip” caps. (In the picture below, the film condensers could not fit in the “stubby” cases, or in the brass Phelon cases either.) So, let's look at the steps needed to rebuild condensers using X7R ceramic elements! Refer to Fig. 4 to see how these Ceramic elements will fit almost any application!

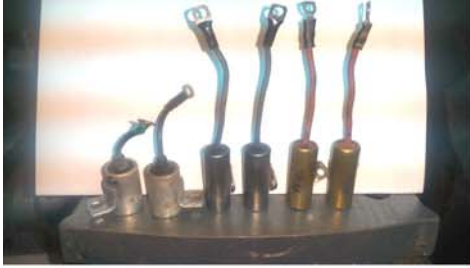
Get a collection of dead (shorted) condensers to modify.

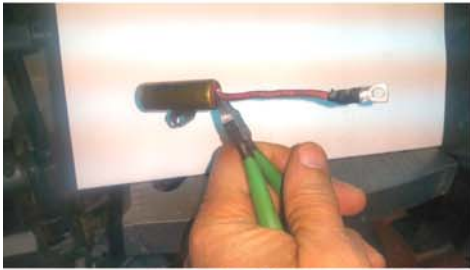
Using side cutters, cut the lead wire off as close to the condenser body as possible.

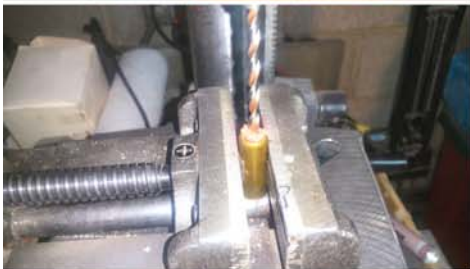
Use a 1/8" drill bit, and drill as many holes as you can, as close to the bottom of the condenser as you can. (Large drill bits cause the core of the condenser to "grab" and spin around, and NOT cut!)

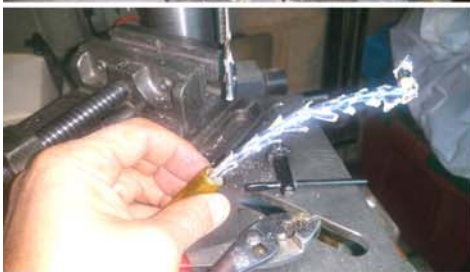
Next, use a small (but strong) pair of needle-nose pliers to pull all of the pieces of the core out of the condenser.

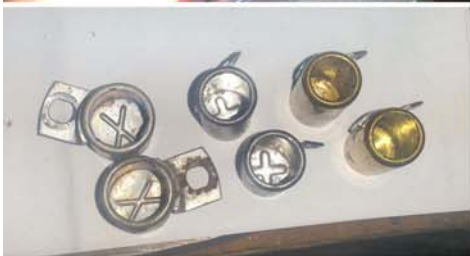
Clean absolutely everything out of the cases; make sure nothing remains.

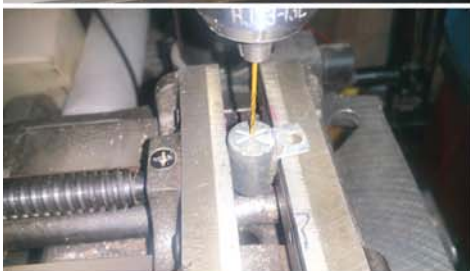
**Fig. 5 - Rebuilding With Ceramic Caps, Part 1**

Drill a 1/16" diameter hole in the bottom of the condenser case. (This is for one of the lead wires to exit the case.)

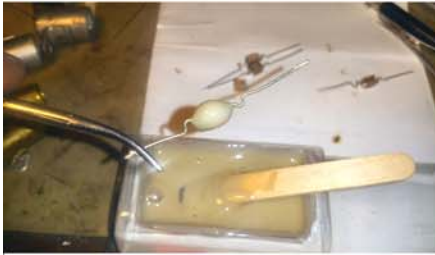
Coat the X7R ceramic "chip" with a layer of 15-minute plastic epoxy. Do not cover the "S" pattern in the wires, as that would defeat their "strain relief" capability.

Wait a few hours for this to cure.

It may not be obvious why I coat the ceramic “chips” with epoxy as a separate step. The reason I do this is because when you solder the lead to the bottom of your old condenser’s case, the heat can easily cause that wire (which is also soldered to one side of the ceramic cap) to so hot that the solder on the ceramic cap melts, and the whole assembly falls apart. Coating the X7R “chips” and their metal wire leads in epoxy makes them look like a “dipped tantalum capacitor” (if you know what that looks like!)...and the epoxy then holds the wires to the case, even if they momentarily get so hot that the solder holding them to the ceramic caps actually melts. This saves a lot of hassles when soldering to the bottom of the old condenser cans. This epoxy coat also keeps the capacitor “chips” from “shorting out” to the insides of the old condenser cans!

There’s another reason for this epoxy coat, and that is that many of your flexible “sealers” contain corrosive ingredients that can harm the ceramic elements. If you use traditional “silicon sealers” for your sealing compound, most of them use ascetic acid, which gives off a strong vinegar-like smell when curing. Other sealing compounds use chemicals in their formulations that are even more corrosive than that.....and this epoxy overcoat protects the X7R elements from anything that might be in your flexible sealing compound.

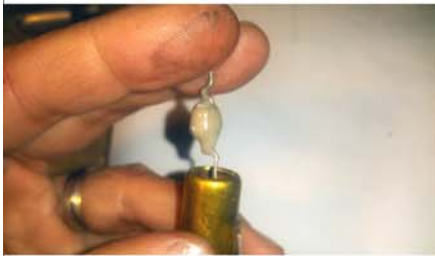
Insert the coated X7R chip and lead assemblies into the empty condenser cases. Thread the bottom lead through the hole in the bottom of the case.

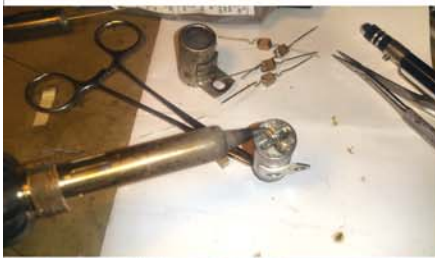
Turn the case upside-down. Bend the lead over flush with the bottom of the case. Cut the lead about .2" long from the hole in the case. Then, solder the lead to the case. Flow the solder around a bit to "feather" it in, hiding the wire.

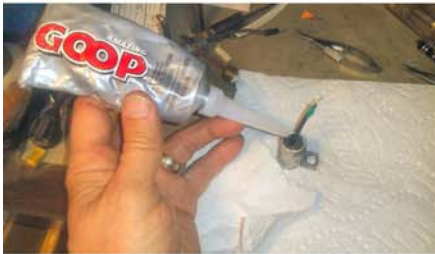
Use silicon sealer (or any other soft sealing compound) and fill the case up to within .2" of the top of the case.

Wait 24 hours for the sealer to cure.

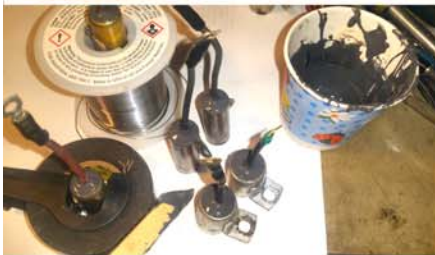
Fig. 6 - Rebuilding with Ceramic Caps, Part 2

Mix up a batch of epoxy (I use JB Weld). Fill the rest of the case up to the top. Wipe with paper towel, to smooth the epoxy out. Wait another 24 hours to cure.

Your condensers are now ready to use!
